**MECHANICAL STRENGTH DETERMINATION OF CRUSHED STONE  
AGGREGATE FRACTION FOR ROAD PAVEMENT CONSTRUCTION  
(CASE STUDY: SELECTED QUARRIES IN WESTERN NIGERIA)**

**Olutaiwo A. O<sup>1</sup>., Ashamo A. A.<sup>2</sup> and Adanikin, A.<sup>3</sup>**

*1,2 -Department of Civil and Environmental Engineering, University of Lagos, Akoka, Nigeria.  
3- Department of Civil & Environmental Engineering, Elizade University, Ilara-Mokin, Nigeria.*

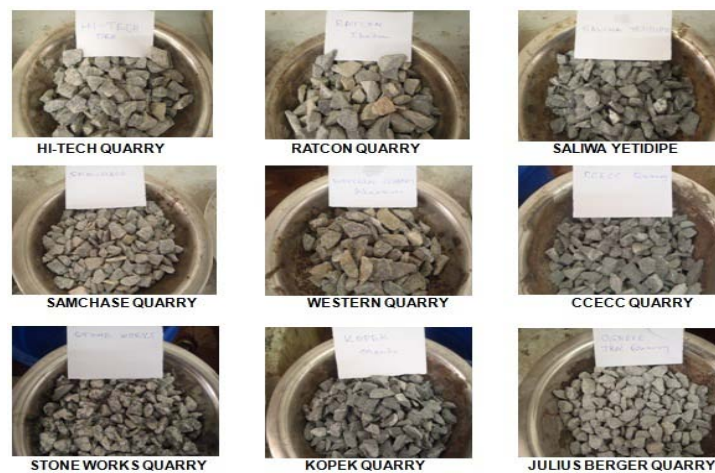
**Figure 2.1: Aggregate Samples from the Nine Selected Quarries**

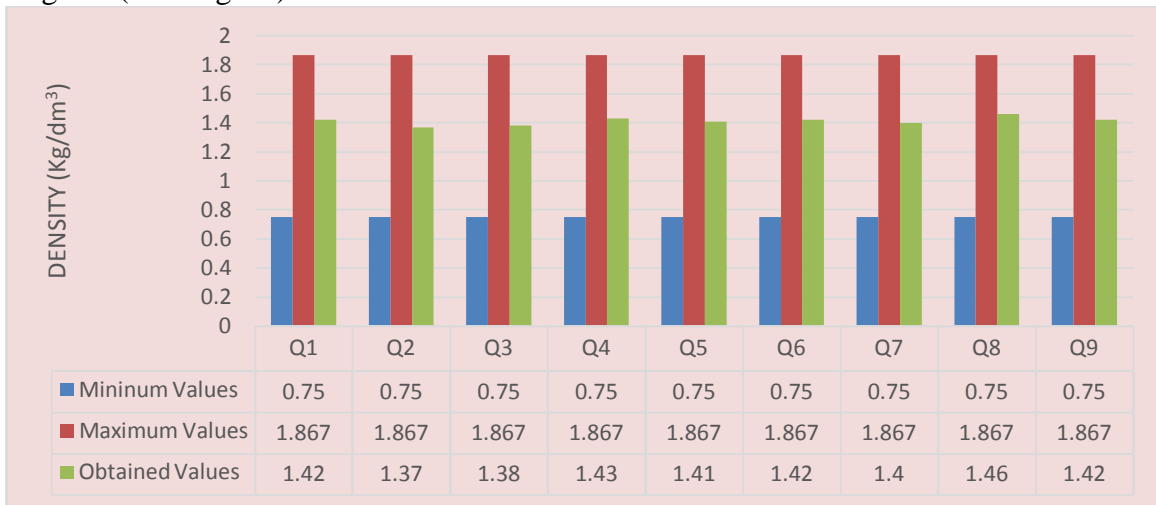
Samples with higher values of the aggregate loose density are likely to possess higher strength if the other requirements of properties that enhance strength are equally met. Any aggregate with loose density less than  $0.75\text{Kg/dm}^3$  ( $750\text{Kg/m}^3$ ) as specified by the BS 812 Part 2: 1995 is not good for road pavement construction. The summary of the tests (Figure 3.1) revealed that all the samples from different quarries tested passed the loose density test with Sample Q8 being the highest with  $1.46\text{Kg/dm}^3$  ( $1460\text{Kg/m}^3$ ) while Q2 has the lowest value of  $1.37\text{Kg/dm}^3$  ( $1370\text{Kg/m}^3$ ). and this is as shown in.

Figure 3.1: Graphical Representation of Sampled Aggregates Loose Density
